# Performance of Strip Seals in Iowa Bridges, Pilot Study

FINAL REPORT

Iowa Highway Research Board  
Project TR-437

Iowa State University

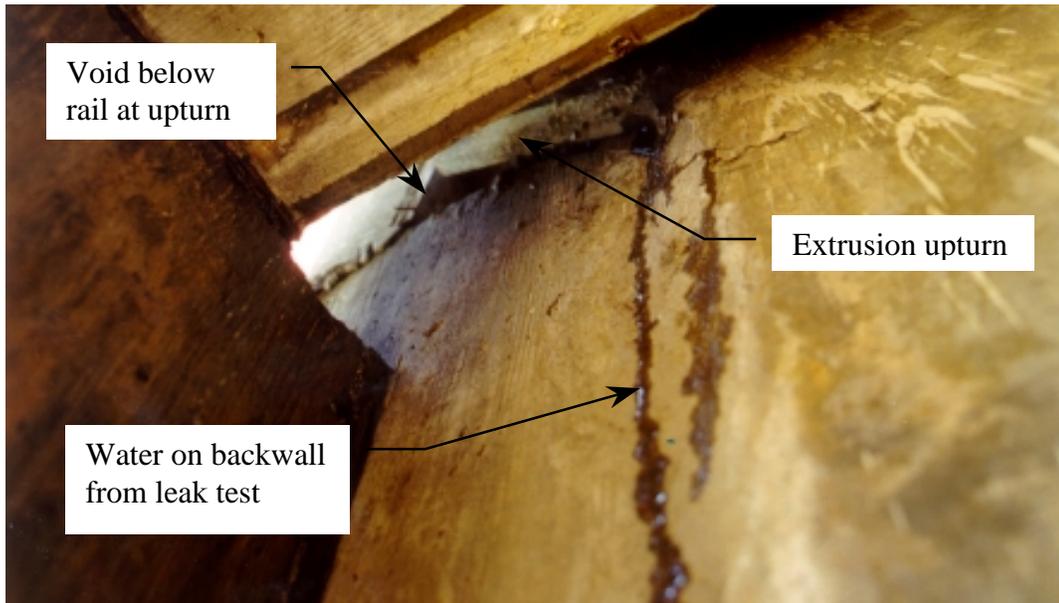
Figure 6.33 Leaking below the right gutter at G1 of Bridge 9 (6485.3L030)

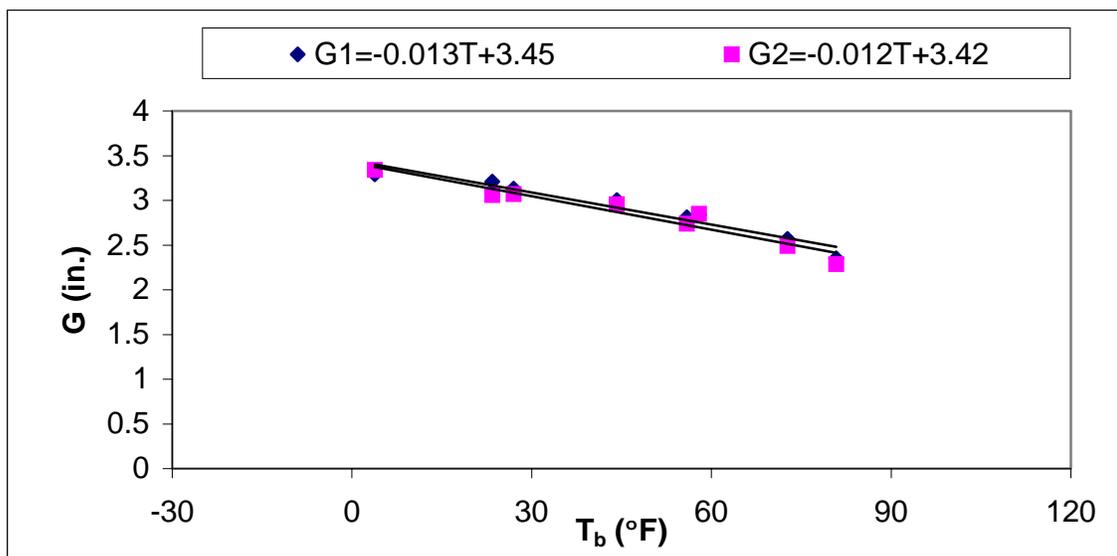
Figure 6.34 Gap opening vs. representative bridge temperature for Bridge 9 (6485.3L030)

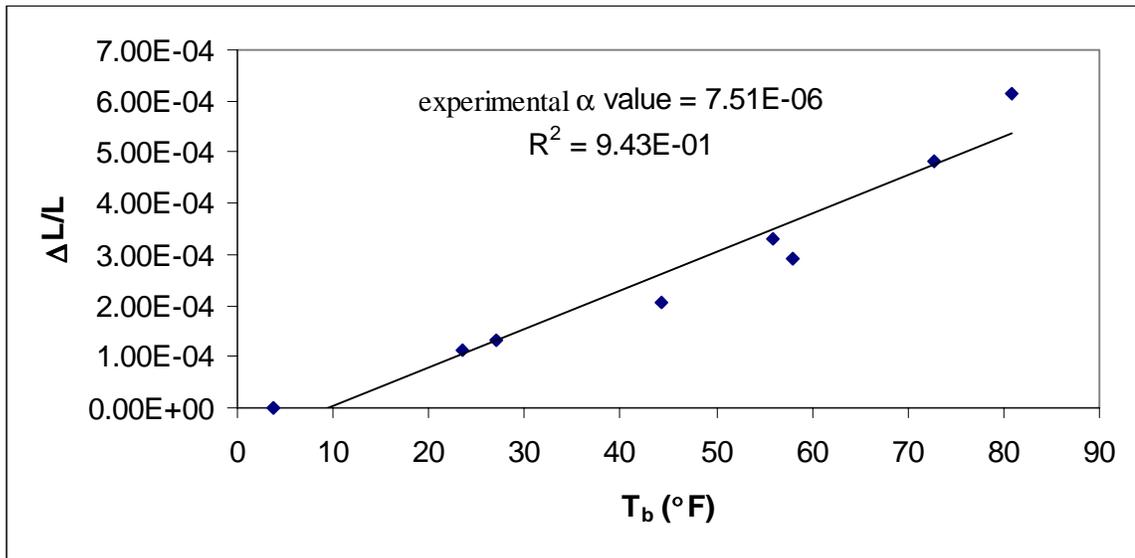
Figure 6.35 The experimental  $\alpha$ -value for Bridge 9 (6485.3L030)

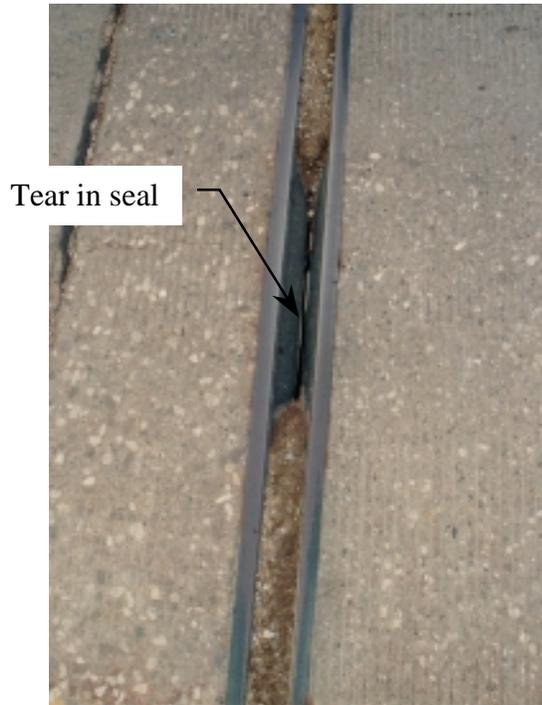
Figure 6.36 Strip seal at G1 for Bridge 10 (6402.0S014)

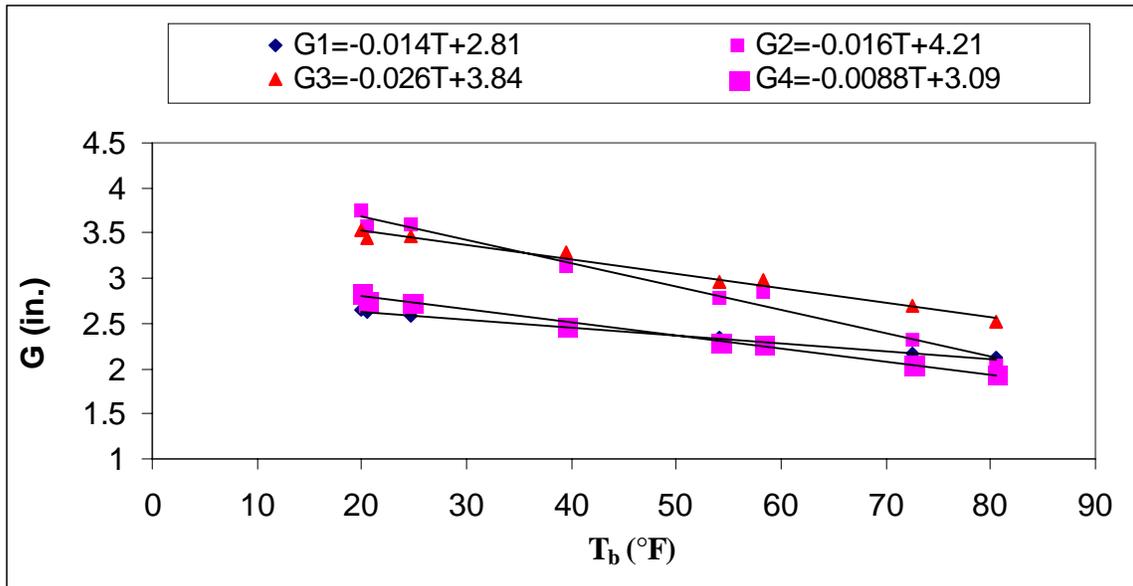
Figure 6.39 Gap openings vs. bridge temperature for Bridge 10 (6402.0S014)

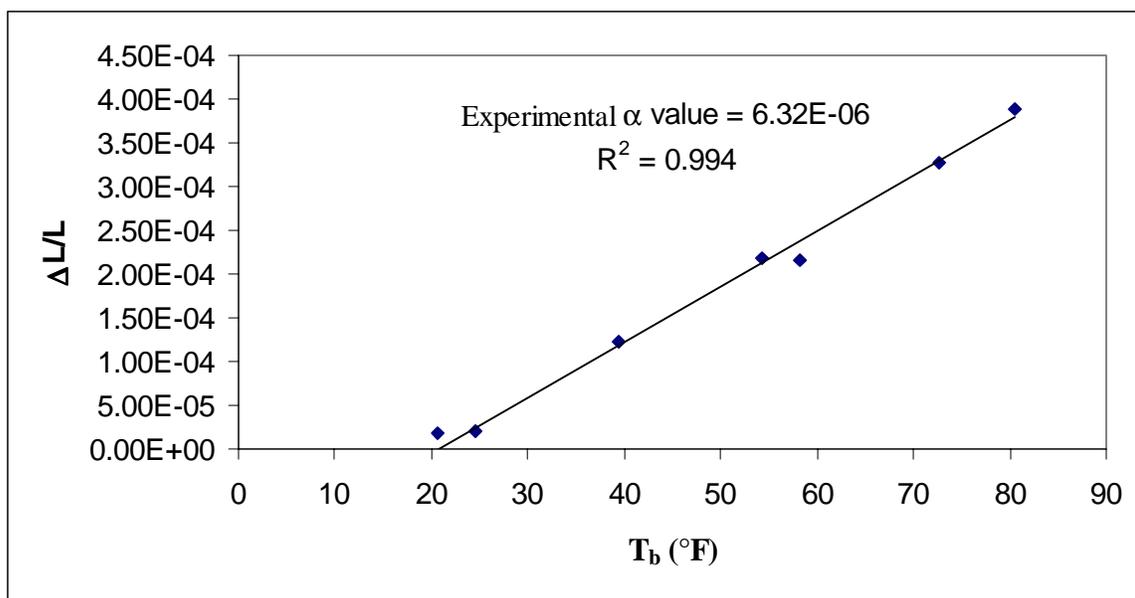
Figure 6.40 The experimental  $\alpha$ -value for Bridge 10 (6402.OS014)

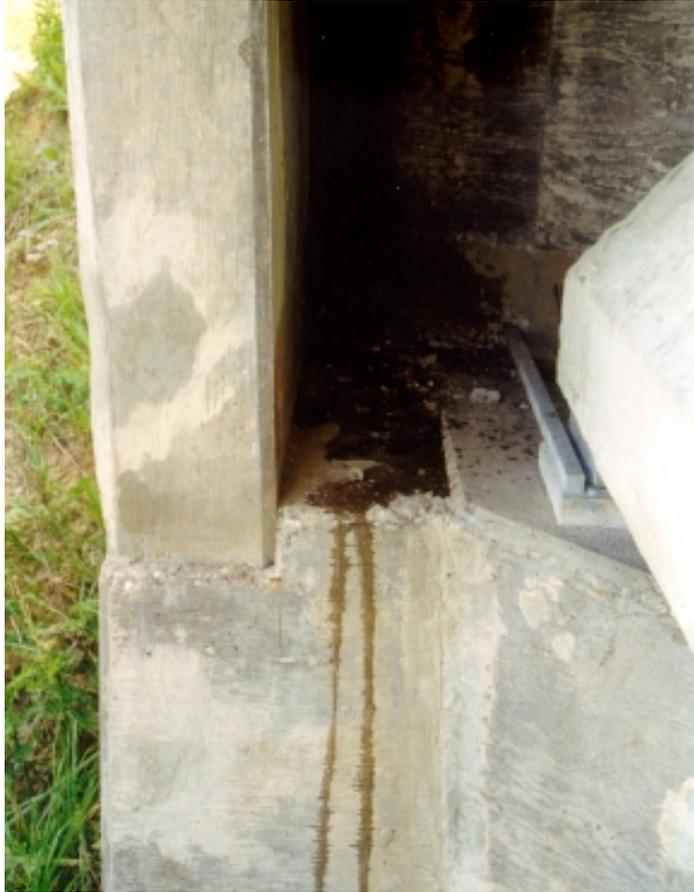
Figure 6.41 Leakage observed underneath G2 for Bridge 11 (6403.6L014)

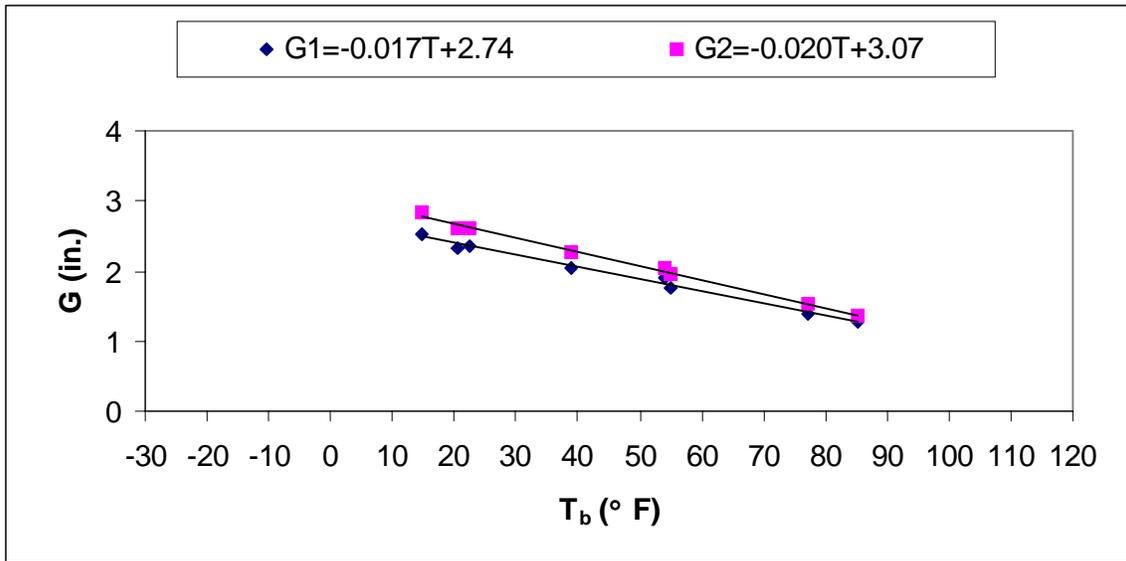
Figure 6.42 Gap opening vs. bridge temperature for Bridge 11 (6403.6L014)

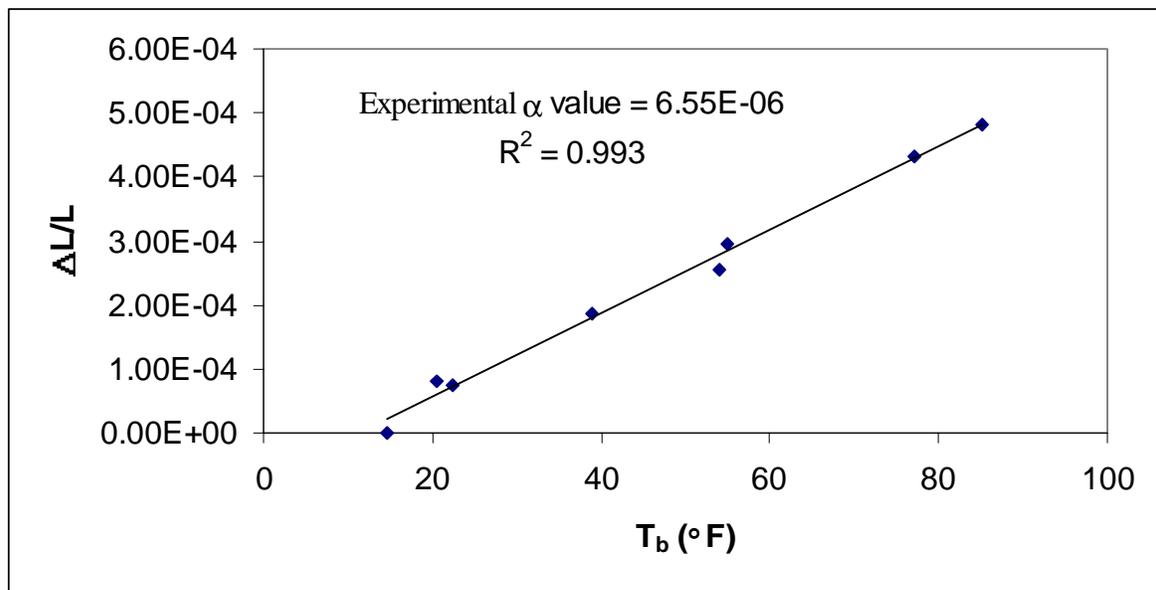
Figure 6.43 The experimental  $\alpha$ -value for Bridge 11 (6403.6L014)

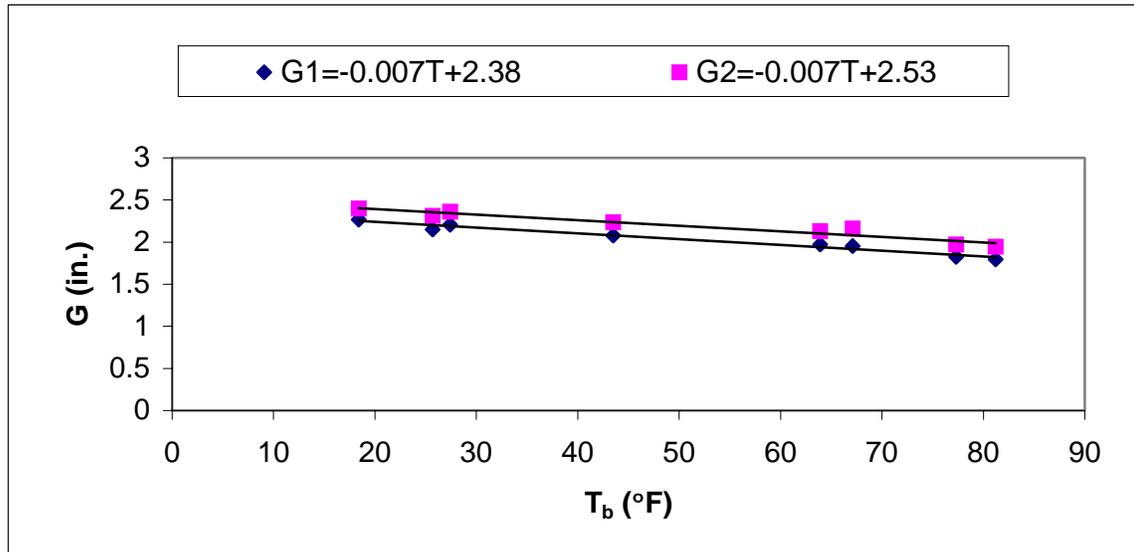
Figure 6.44 Gap opening vs. bridge temperature for Bridge 12 (6481.9L030)

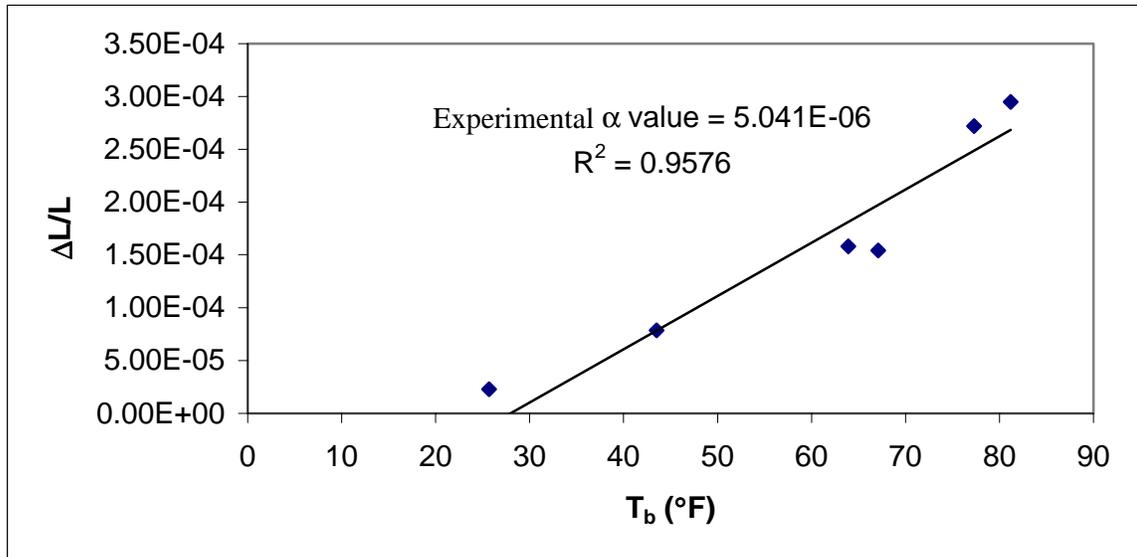
Figure 6.45 The experimental  $\alpha$ -value for Bridge 12 (6481.9L030)

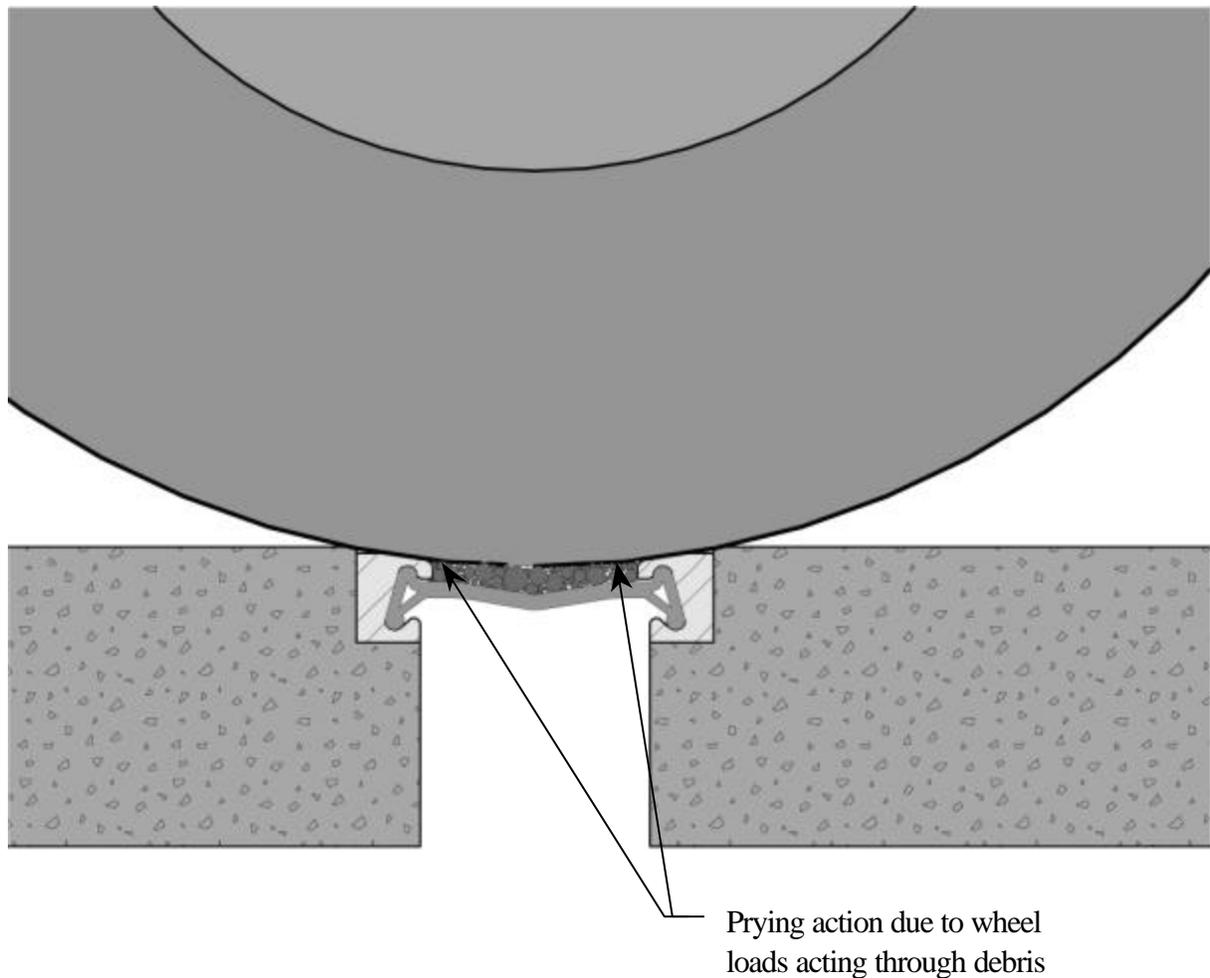
Figure 7.1 Interaction of wheel, seal, and debris when gap is near seal rating
